DAMAGE PROFILES IN SILICON AND THEIR
IMPACT ON DEVICE RELIABILITY

Guenter H. Schwuttke

International Business Machines Corporation

1 January 1974

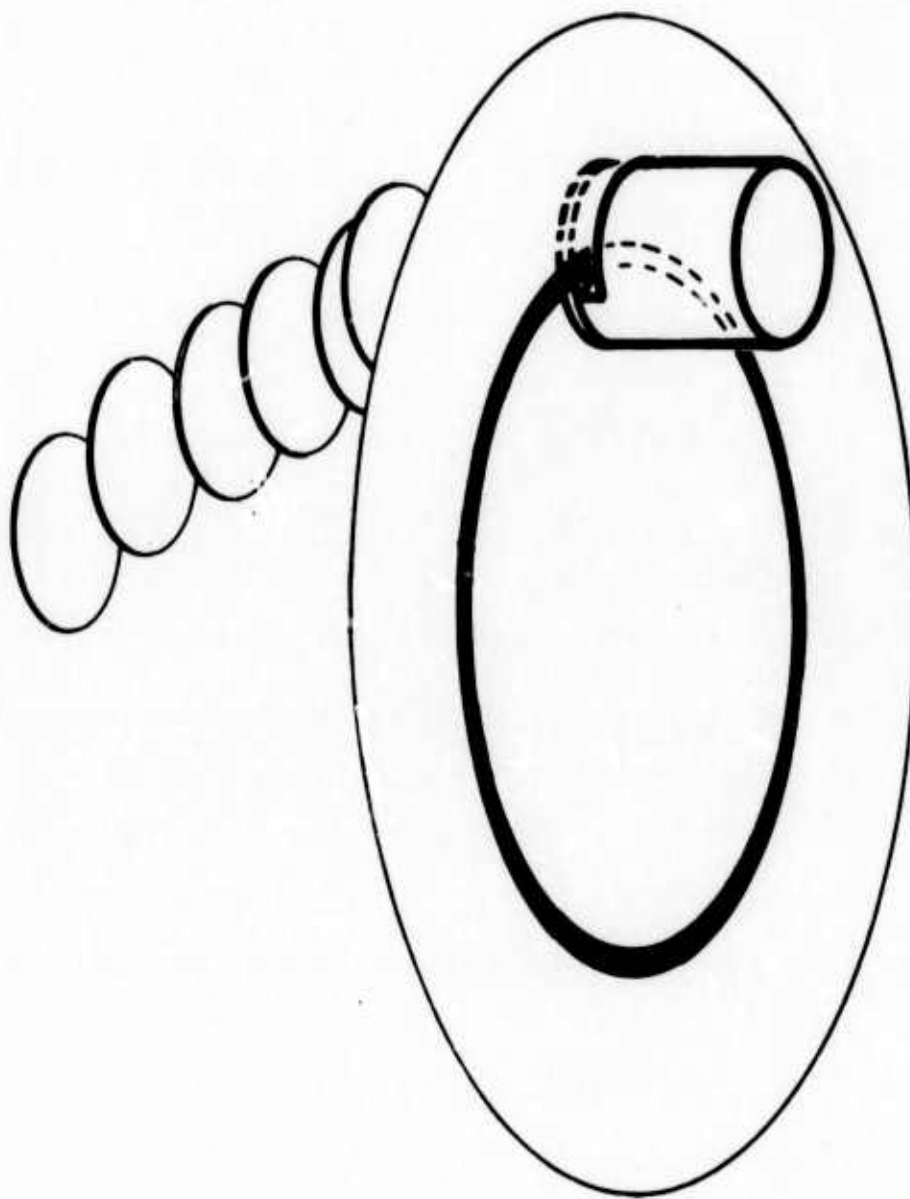
Fig. 1a. Horizontal ID slicing of crystal (H-wafer).

Previously, it was found that the amount of residual saw damage still present in the silicon surface after chemical-mechanical polishing seems to depend on the wafer position in the crystal, and also seems to vary considerably with the slicing technique. Higher MOS capacitor/wafer yield was obtained on wafers cut close to the seed part of the crystal and also better yield was obtained on H-wafers (horizontally sliced, Fig. 1a) as compared to V-wafers (vertically sliced, Fig. 1b).^{1,2}

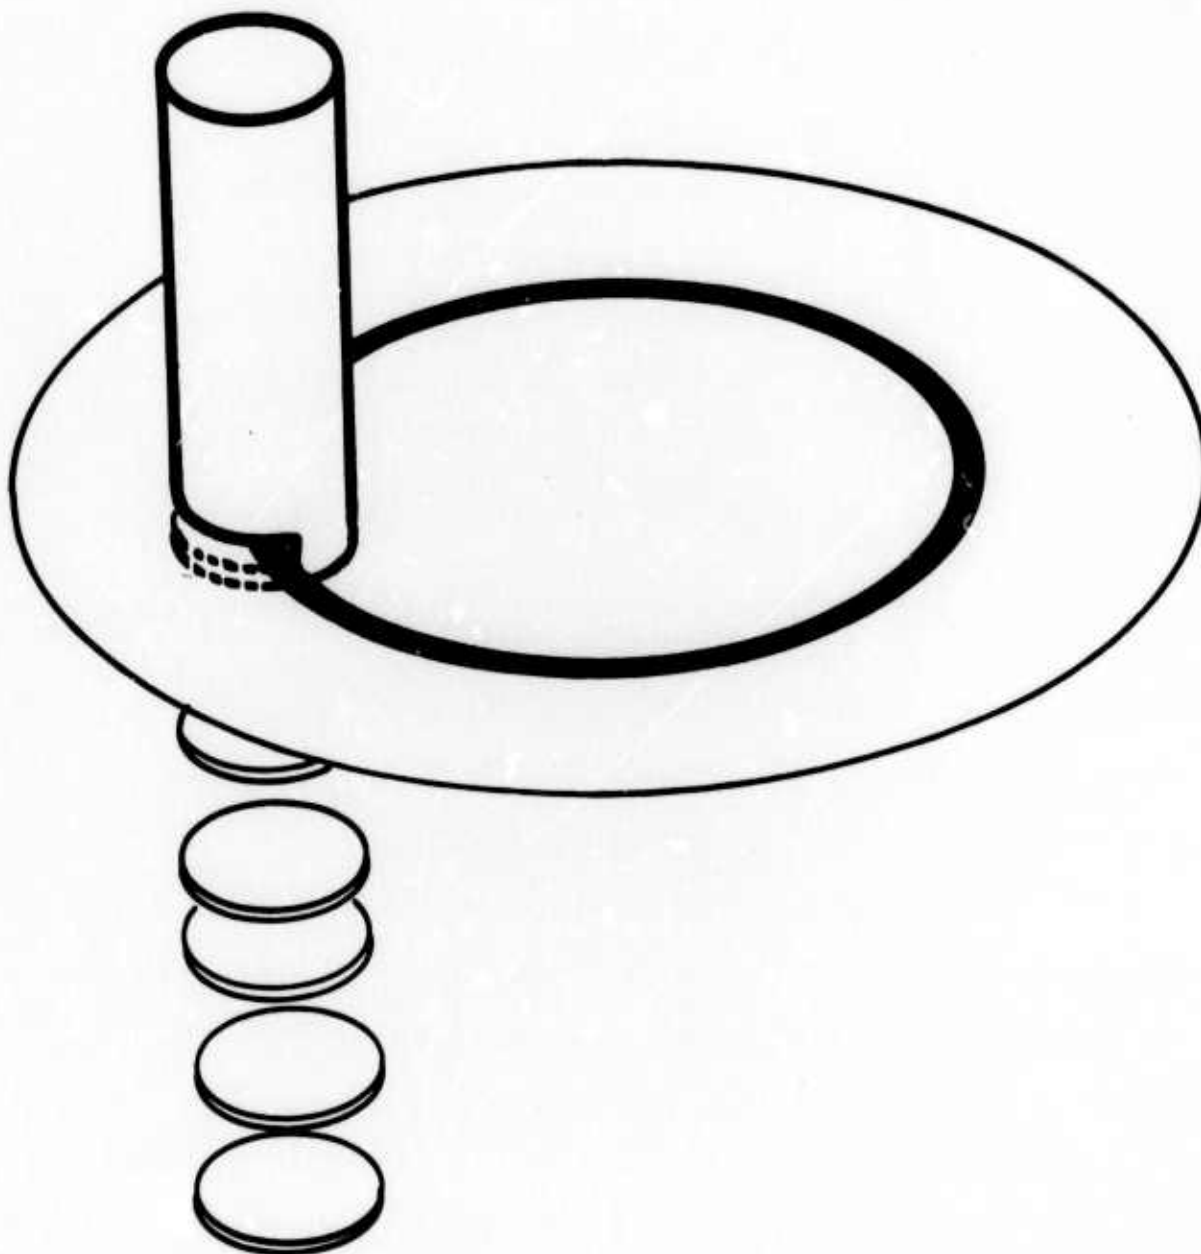
Fig. 1b. Vertical ID slicing of crystal (V-wafer).

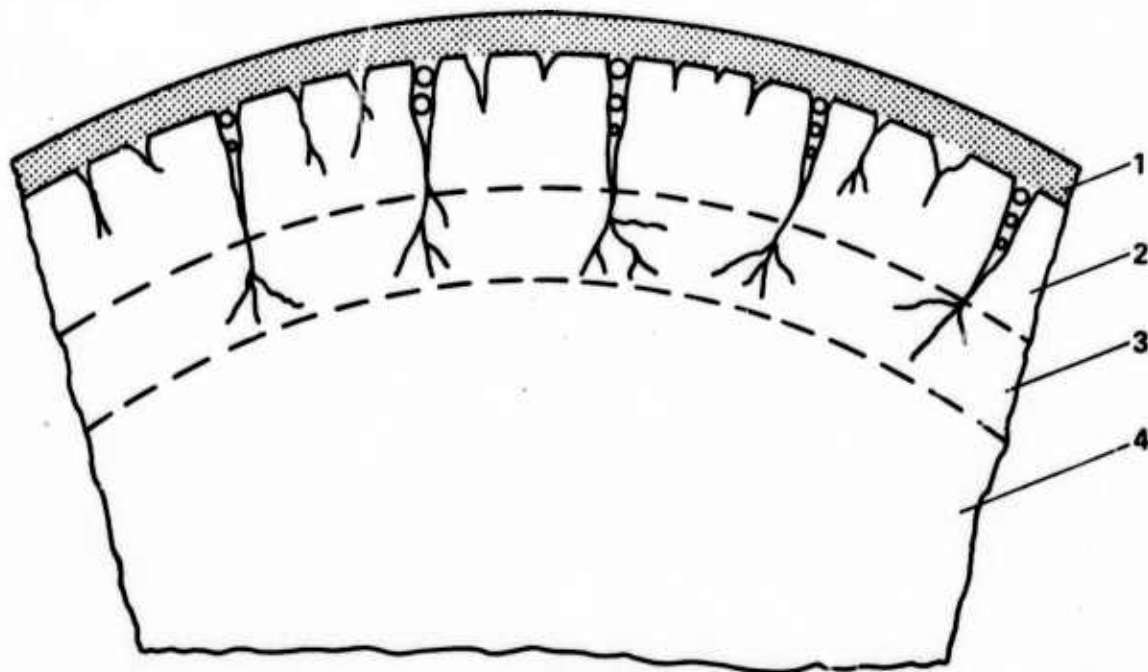
Fig. 2. Damage model showing simplified outline of structure of sawed single crystal surface.

- 1. Cracks and dislocation network.**
- 2. Dislocation and cracks.**
- 3. Microsplits.**
- 4. Perfect crystal.**

A damage model based on these ideas is shown schematically in Fig. 2.

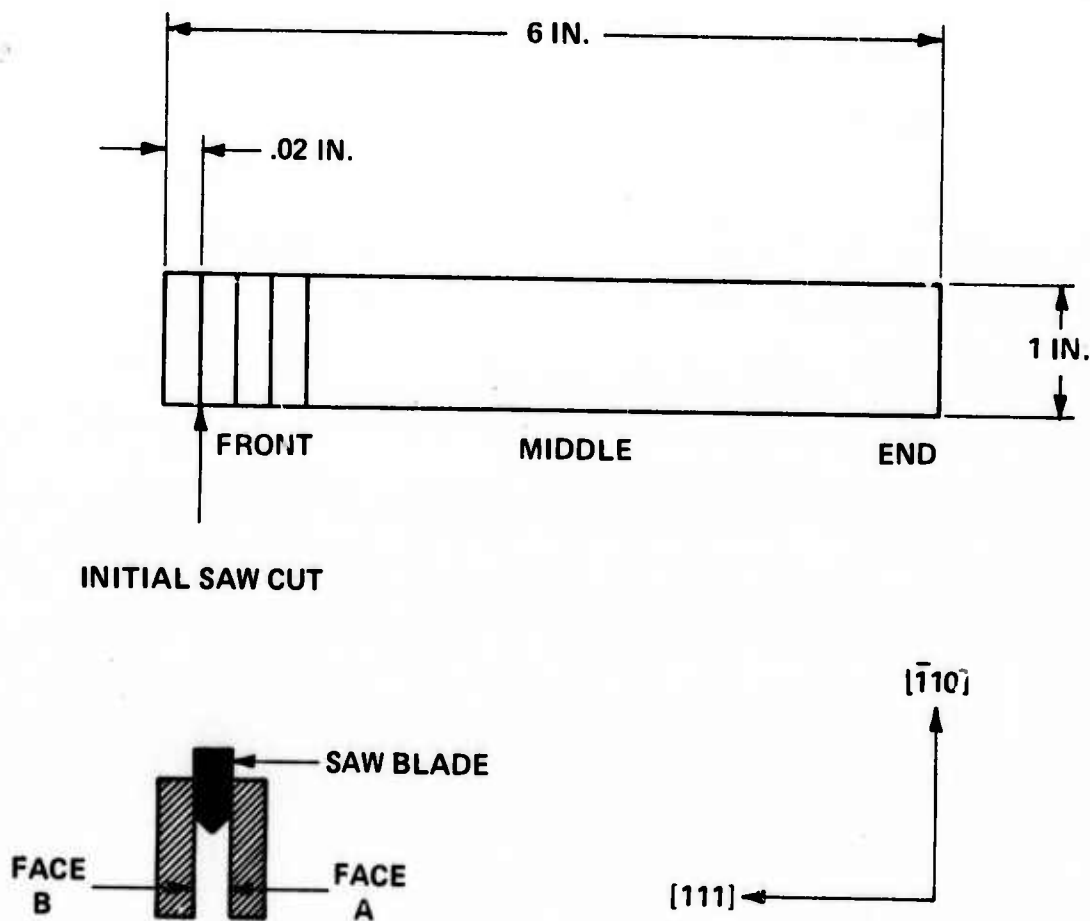
Fig. 3. System of identification used in this report.

Figure 3 depicts the schematic of a wafer identification system used. The location of the wafer face relative to the saw blade is identified by arbitrarily labeling the wafer surface which is attached to the crystal bulk during cutting as A. The wafer surface on the opposite side of the blade is designated B. Samples are selected from the front, middle, and end of the crystal, and their surfaces are identified accordingly as A or B samples.

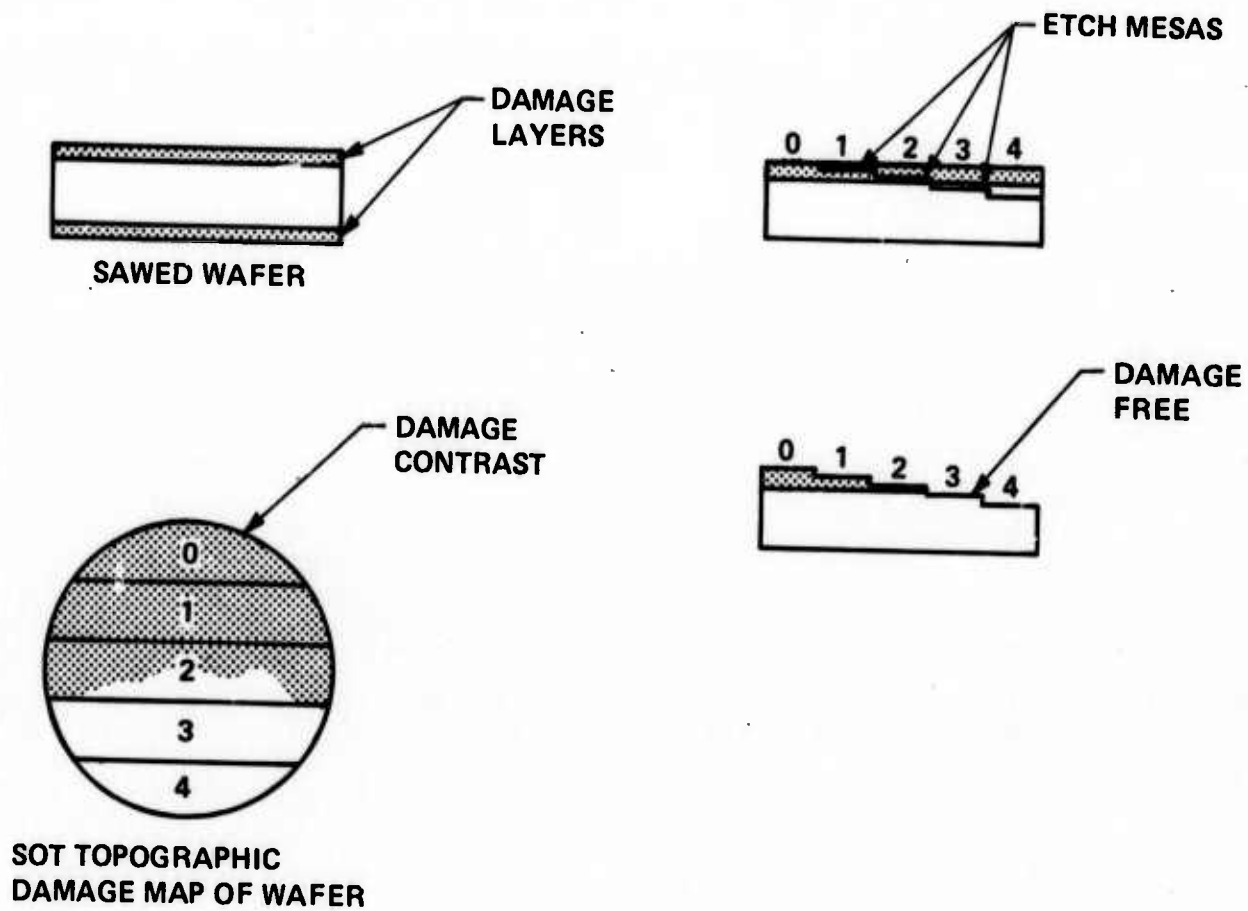
Fig. 4. SOT topography and damage distribution in wafer.

SOT topography records topographs of entire crystal wafers several inches in diameter even in the presence of elastic strains.¹² Saccocio and McKeown¹³ have shown that a single SOT topograph of a step-etched wafer can reveal the extent and also the distribution of damage in a saw-cut silicon slice. We have applied this technique to characterize crystal shaping processes in terms of saw damage. Our approach is shown schematically in Fig. 4. Accordingly, the sawed wafer contains a damage zone on both the A and B surfaces (not necessarily equal in depth). For the analysis of contiguous A and B surfaces, two adjacent wafers are used. The A surface on one wafer and the B surface of the other slice are step-etched in a solution of 3 parts $\text{HC}_2\text{H}_3\text{O}_2$, 2 parts HNO_3 and 1 part HF . Thus a series of steps or mesas is made through the damaged layer. Each step exposes a different level of damage. These steps are shown schematically in Fig. 4 and are labeled from 0 to 4. The step height is measured as described by Saccocio and McKeown,¹³ which is satisfactory for evaluating gross damage. Samples can be examined incrementally to a greater depth in the same way simply by masking one half of the wafer on a line normal to the first set of steps and subsequently step-etching the material from the exposed half. In this manner samples were evaluated in increments of $\sim 2.5\mu\text{m}$ down to a depth of $\sim 40\mu\text{m}$ or more.

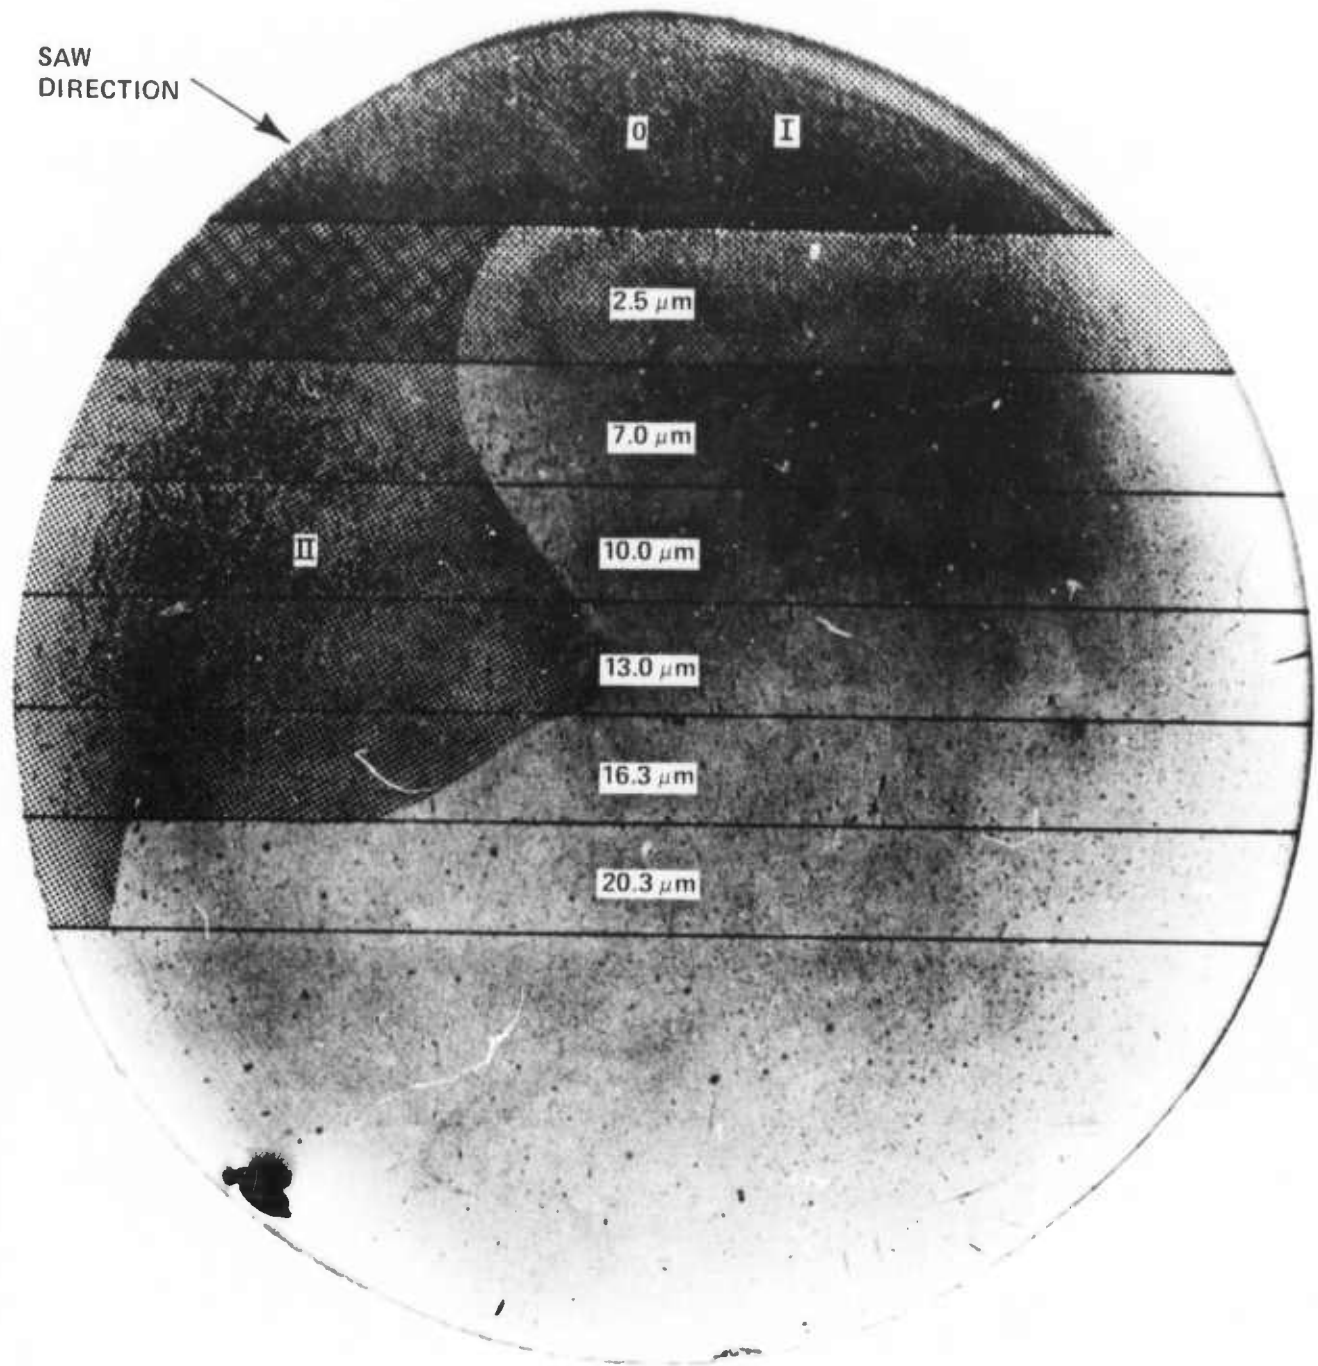
DAMAGE MAP: FRONT B

Fig. 5b. Damage map corresponding to Fig. 5a.

If the two damage types are assumed to be independent, the damage map of Fig. 5b indicates a nonuniform depth of damage (in the direction of saw cut) of $\sim 20\mu\text{m}$.

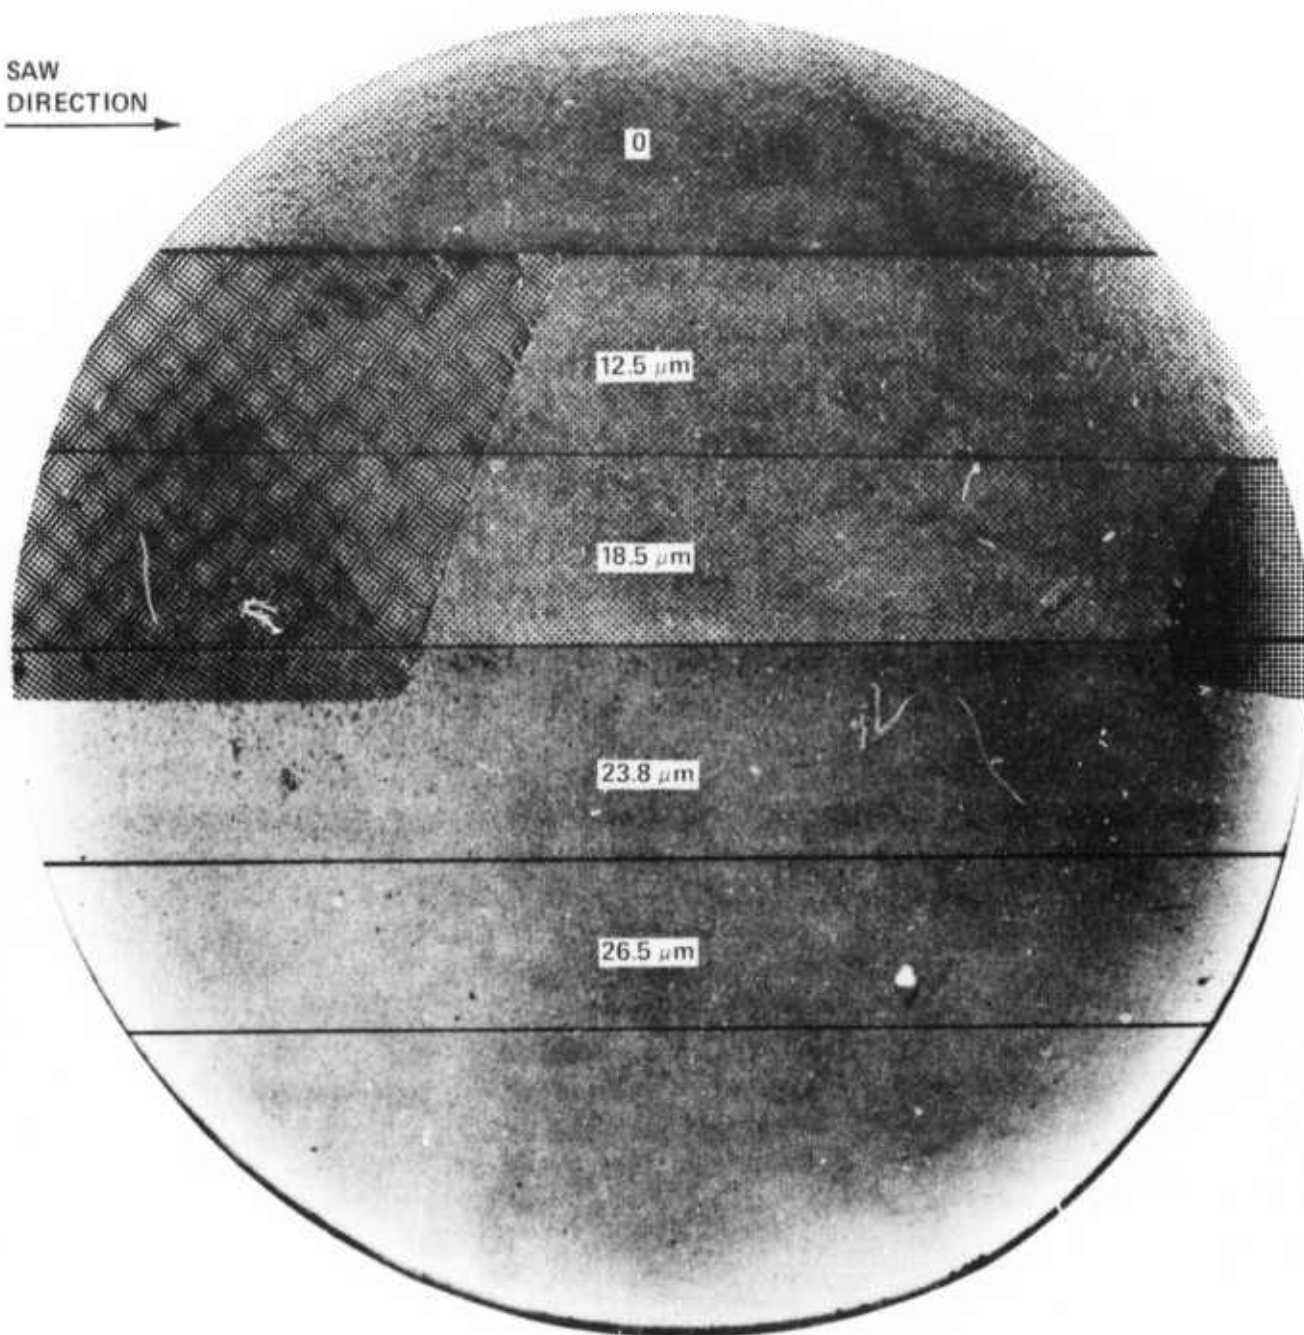
DAMAGE MAP: FRONT A

Fig. 6b. Damage map corresponding to Fig. 6a.

A SOT topograph of the corresponding A surface is shown in Fig. 6a, and a damage map of the same topograph is shown in Fig. 6b. (Note that the surfaces in Figs. 5a and 6a were separated by the same cut.) As shown previously, the maximum contrast occurs in the unetched mesa. In Fig. 6a the damage contrast is reduced uniformly after each step until its final elimination $\sim 24\mu\text{m}$. It should be noted that the incremental variations in x-ray contrast as seen in the topographs of Figs. 5a and 6a give a good qualitative picture of the damage distribution in the crystal interior.

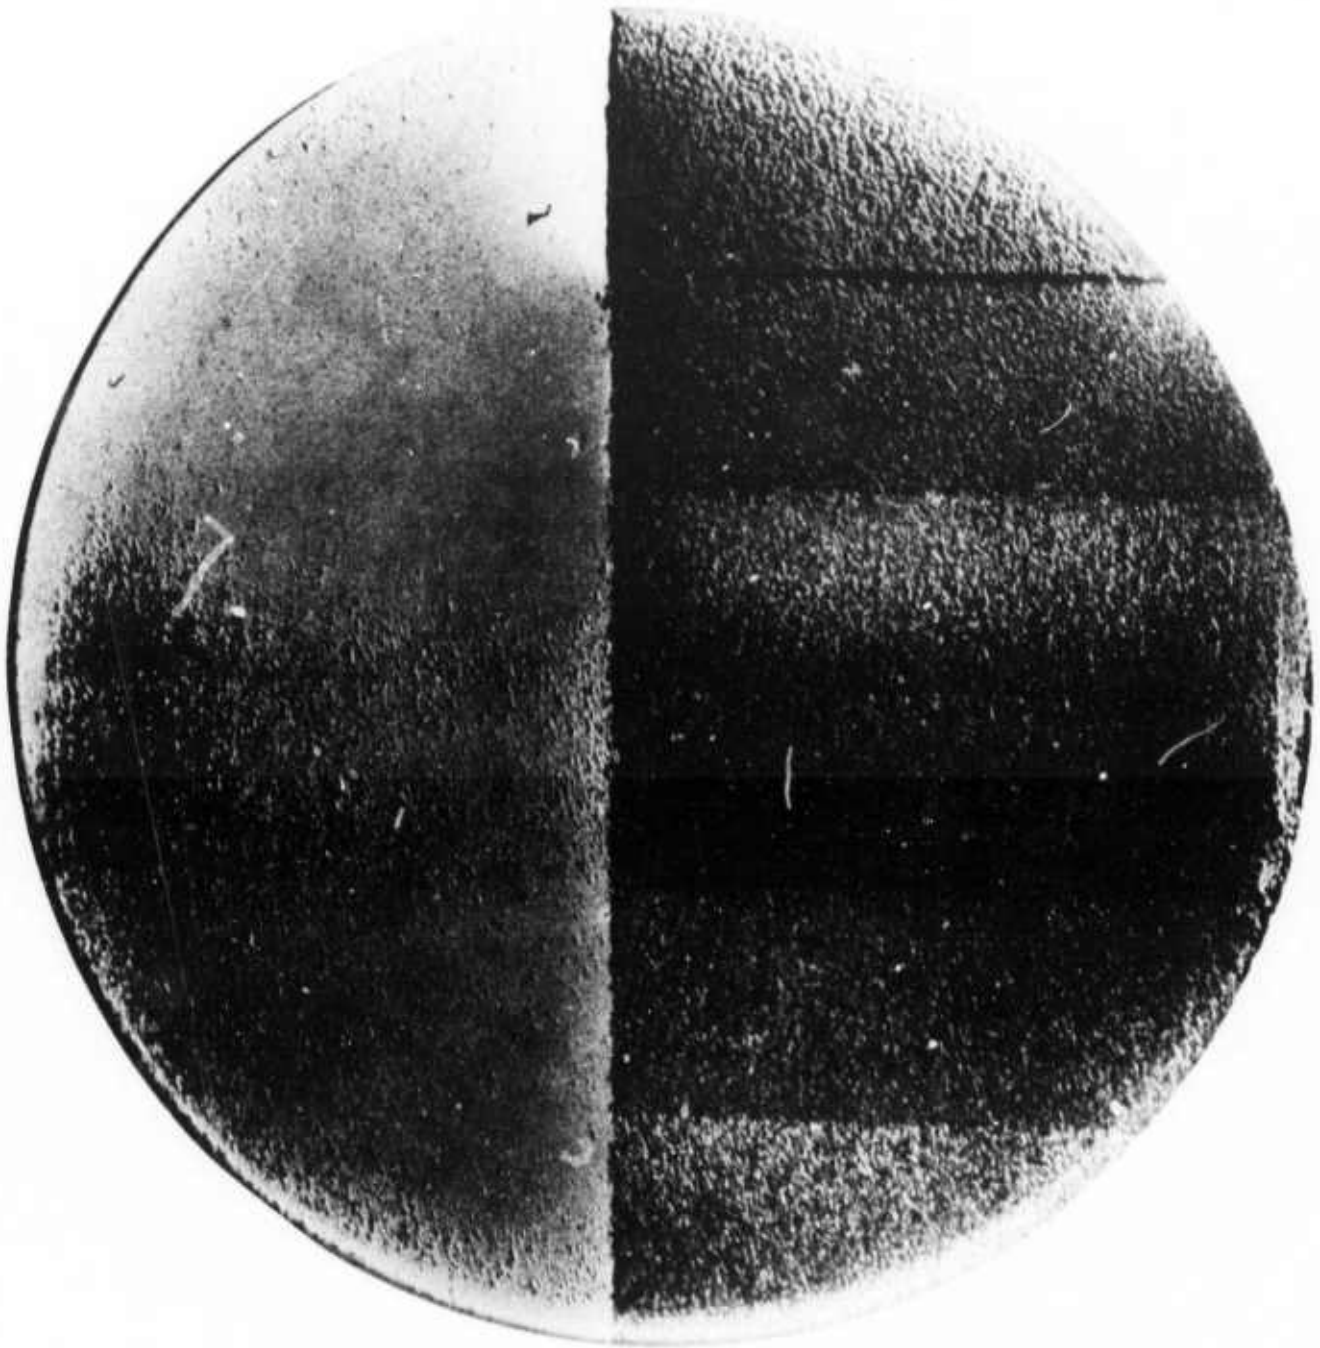
Fig. 7a. SOT topograph of damage in A wafer, middle cut.

A SOT topograph of the A surface of a sample selected from the middle of the crystal is seen in Fig. 7a. Note that this time the damage is more extensive and nonhomogeneous across the A surface than across the B surface. (Note that the A surface of the front cut did not contain nonuniform damage.) The damage map* of Fig. 7b shows that the uniform damaged ends $13\mu\text{m}$ below the surface, whereas the nonuniform component extends

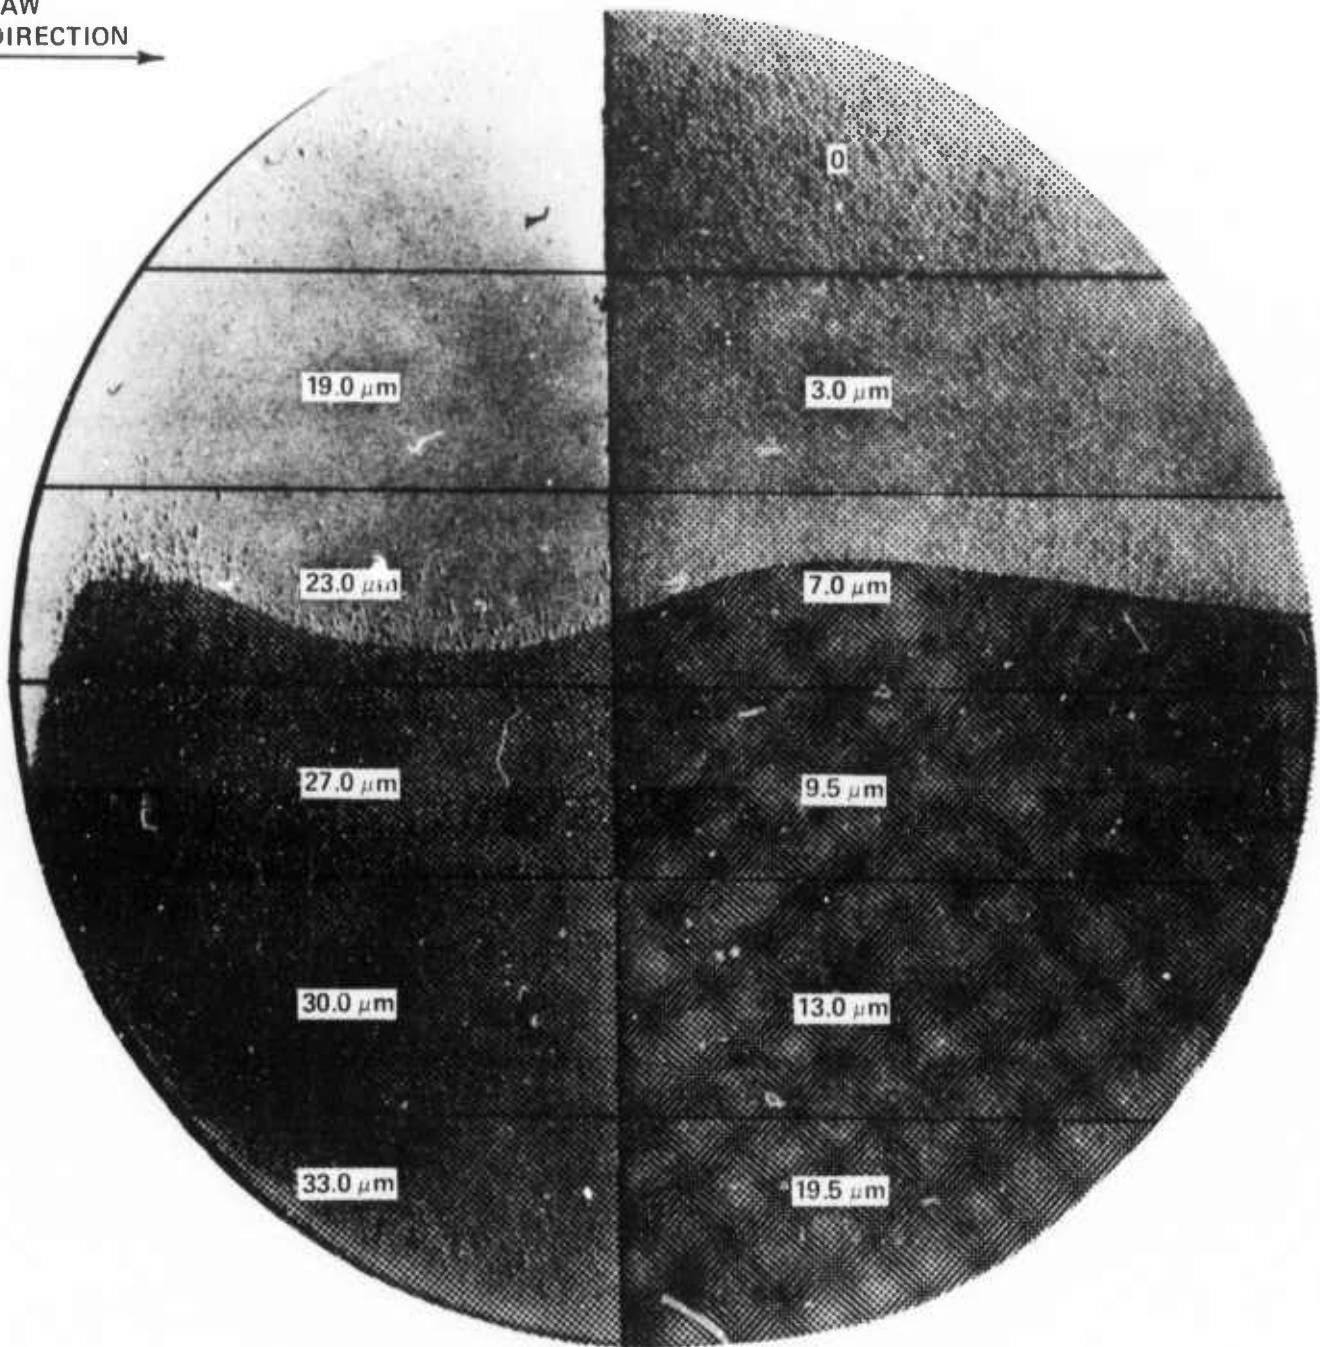
DAMAGE MAP: MIDDLE A

Fig. 7b. Damage map corresponding to Fig. 7a.

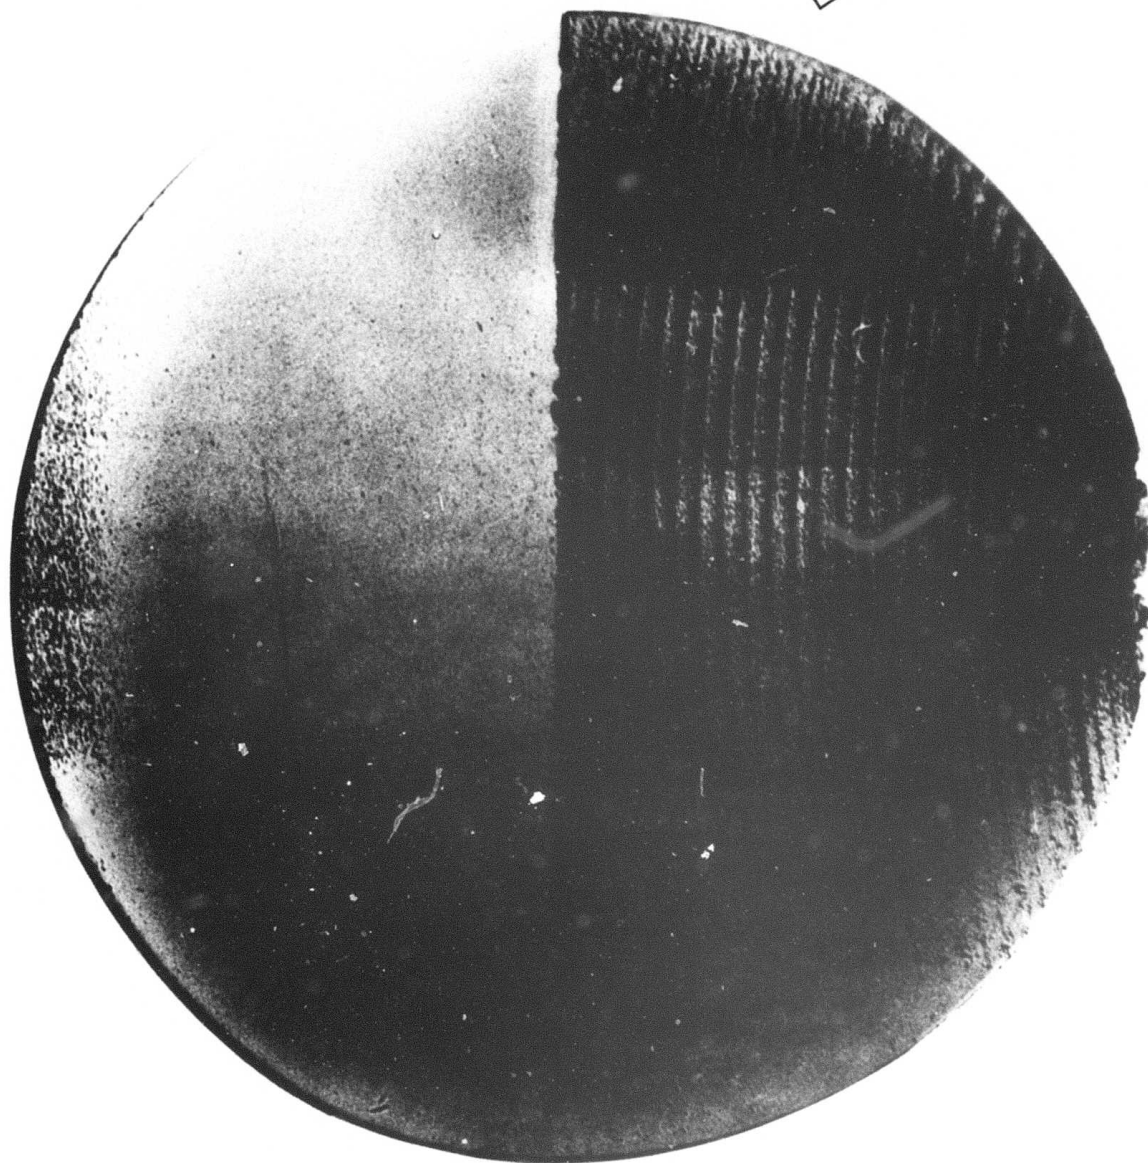
Fig. 8a. SOT topograph of damage in B wafer, middle cut.

deeper than $33\mu\text{m}$. The corresponding B surface shows homogeneous damage plus strong contrast striations (Fig. 8a). In addition, the twice-etched half of the wafer displays peripheral damage. The depth of damage, as displayed in the map (Fig. 8b), is $12.5\mu\text{m}$ for the striations and $27\mu\text{m}$ for the edge damage. Note that the underlying uniform damage disappears at about the same depth as the striations and that the individual striae end at nearly the same depth.

The inhomogeneous damage mode relates obviously to an ill-controlled slicing process. Flutter blade damage in the form of striations and peripheral damage at the point of initial blade contact as shown in Figs. 8 and 10 are a vivid example of what ID slicing should not be like. Changes of saw blade tension are responsible for the striation contrast displayed in the topographs of Figs. 8 and 10. The direction of curvature of the striations relative to the sawing direction suggests further that this type of damage occurs mainly during blade removal. This is in agreement with the polished appearance of the corresponding A surfaces (Figs. 7 and 9) which indicate abrasive contact with the convex side of the deflected blade. The strong edge damage of the B surface in Figs. 8 and 10 at the point of initial blade contact is also an indicator of either irregular blade removal and/or excessive feed rate.

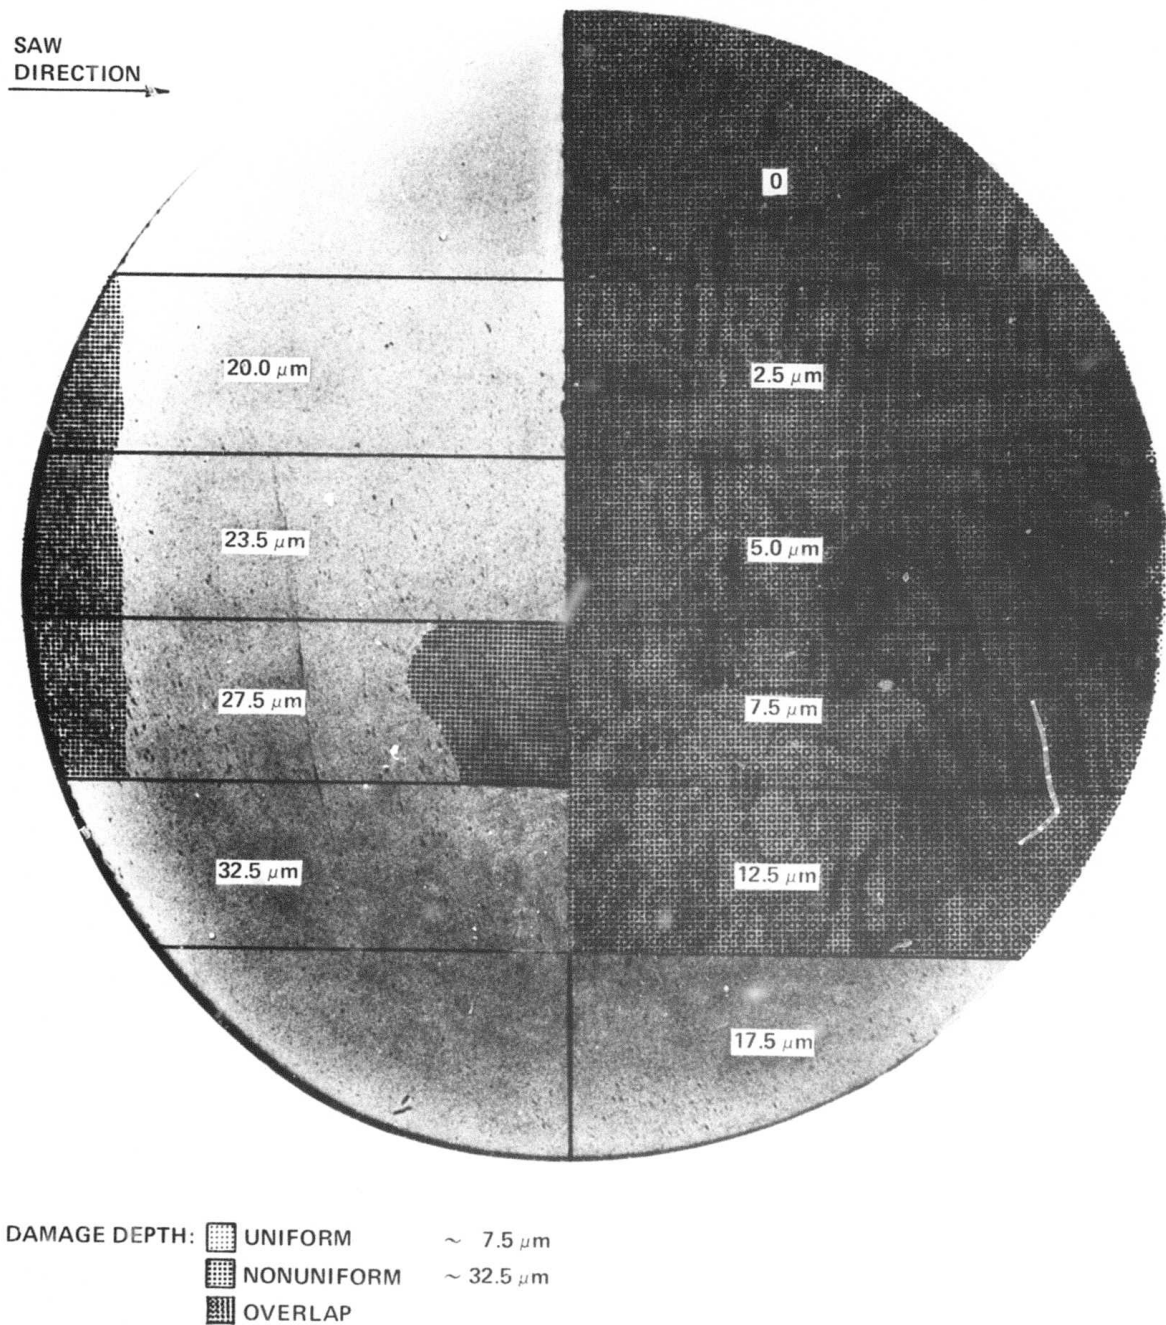
DAMAGE MAP: MIDDLE B

Fig. 8b. Damage map corresponding to Fig. 8a.

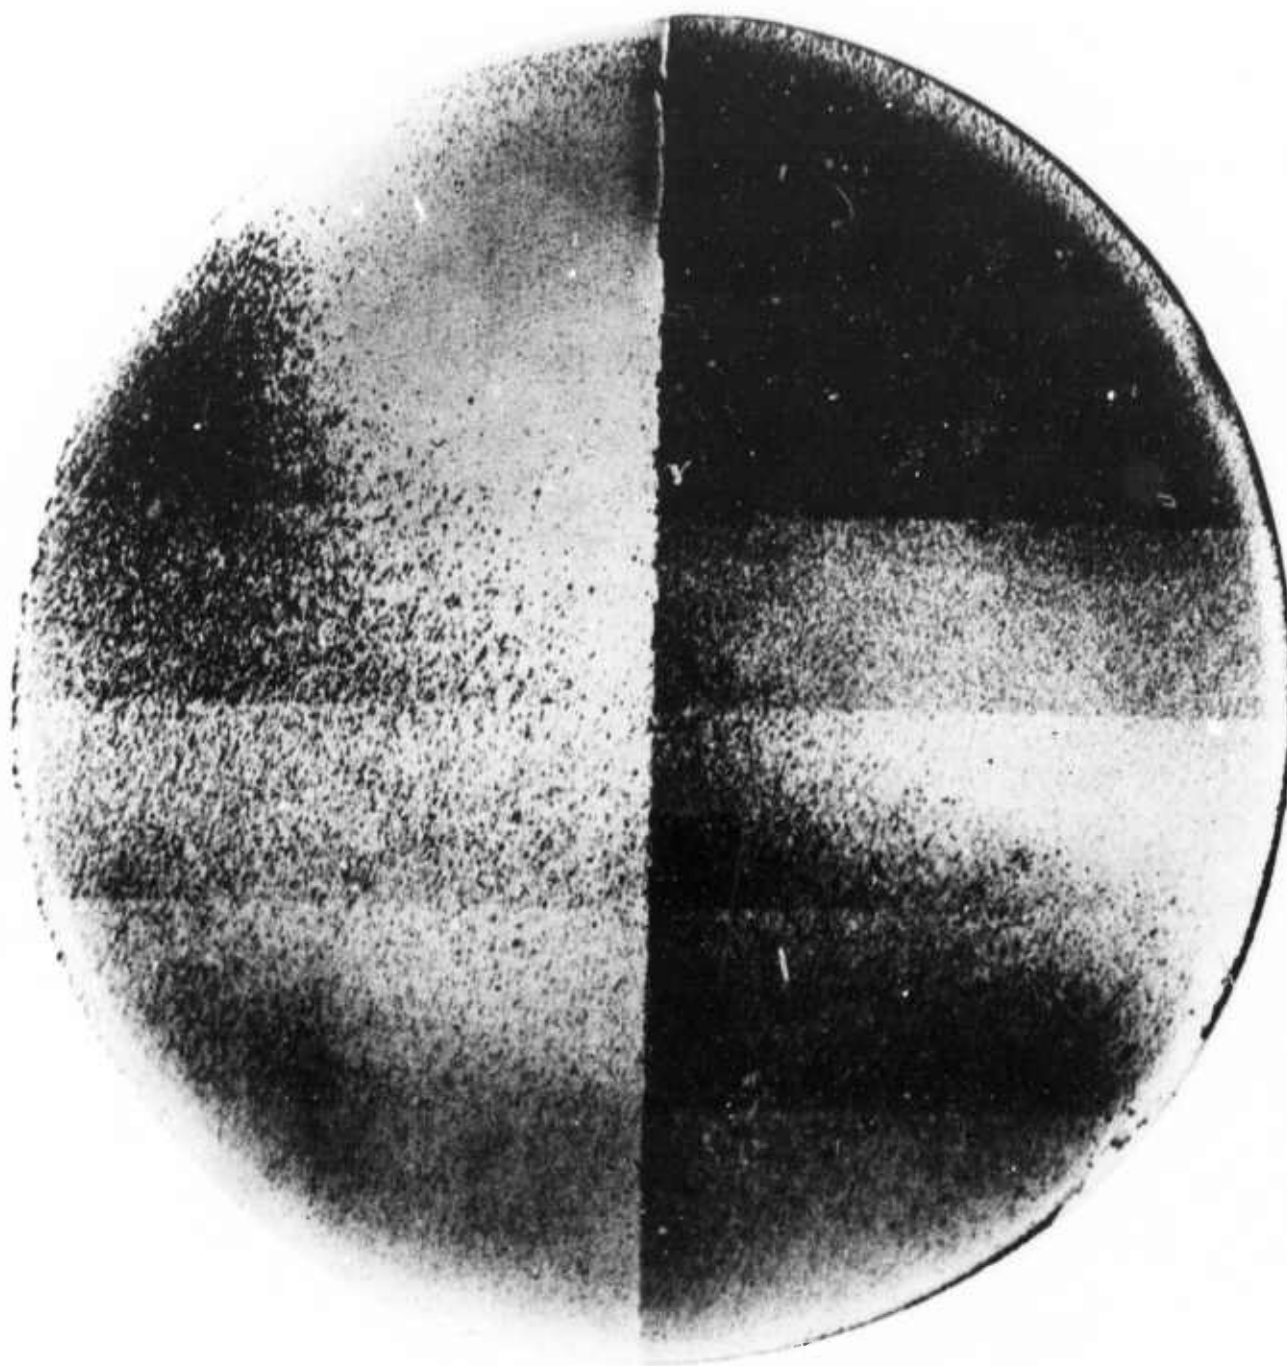
Fig. 9a. SOT topograph of A wafer, cut from end of crystal.

The x-ray topographic images of the A and B surfaces of wafers cut from the end of the crystal are essentially identical to Figs. 7a and 8a and are shown in Figs. 9a and 10a. The nonuniform damage in the A surface (Figs. 9a) has a polished appearance similar to the one shown in Fig. 7a; the nonuniform damage in the B surface (Fig. 10a) consists of striations and edge damage of the type shown in Fig. 8a. The damage map of the A surface is shown in Fig. 9b. The uniform damage is removed after $8.5\mu\text{m}$, and the nonuniform damage is more than $32.5\mu\text{m}$ deep. The B surface map (Fig. 10b) indicates $\sim 9.5\mu\text{m}$ of uniform damage and $35.5\mu\text{m}$ of nonuniform edge damage.

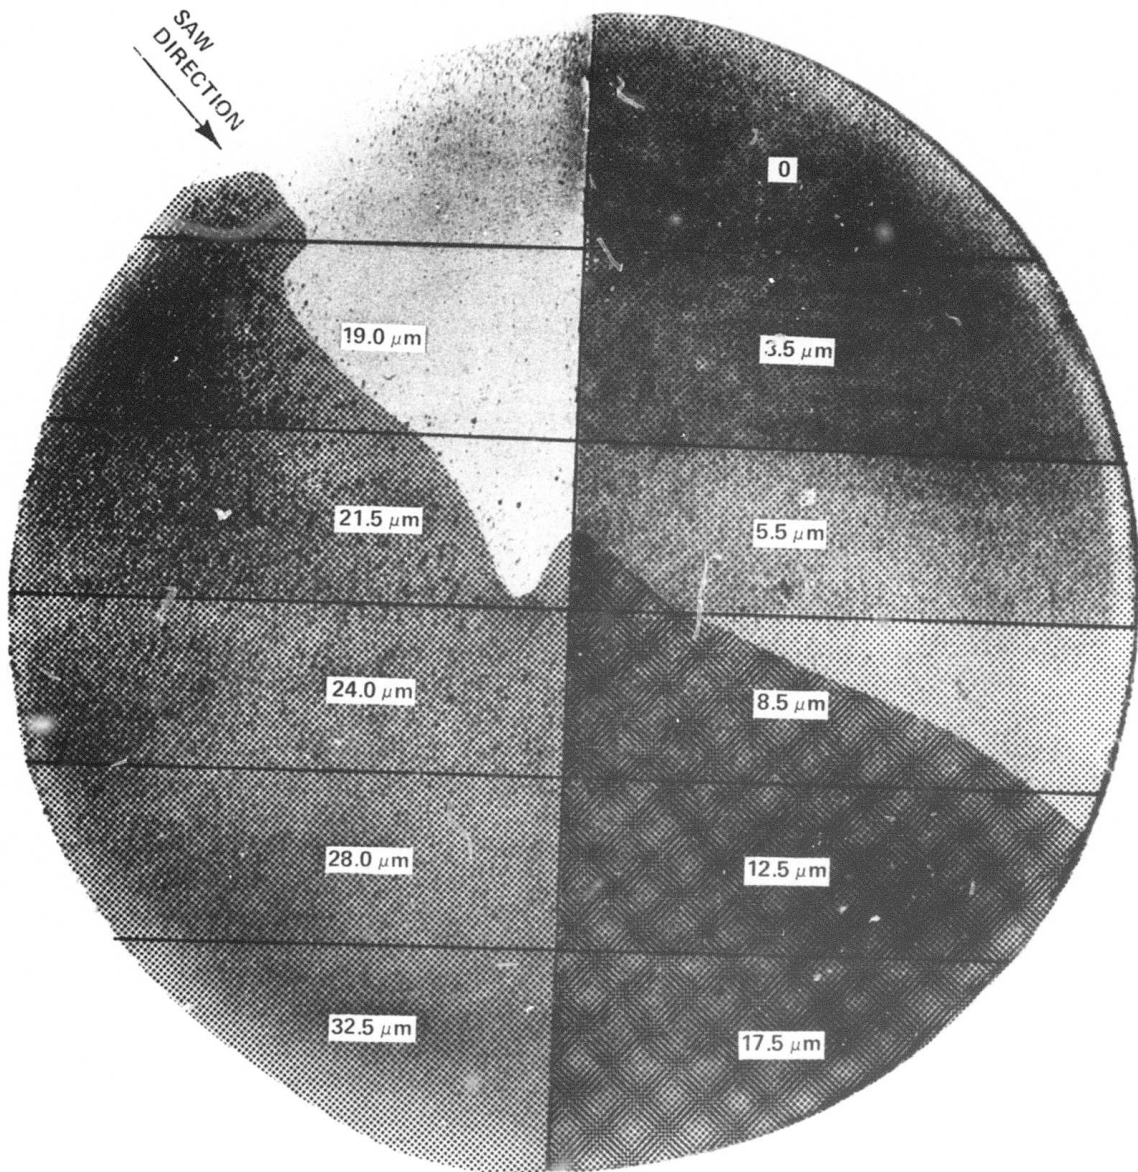
DAMAGE MAP: END A

Fig. 9b. Damage map corresponding to Fig. 9a.

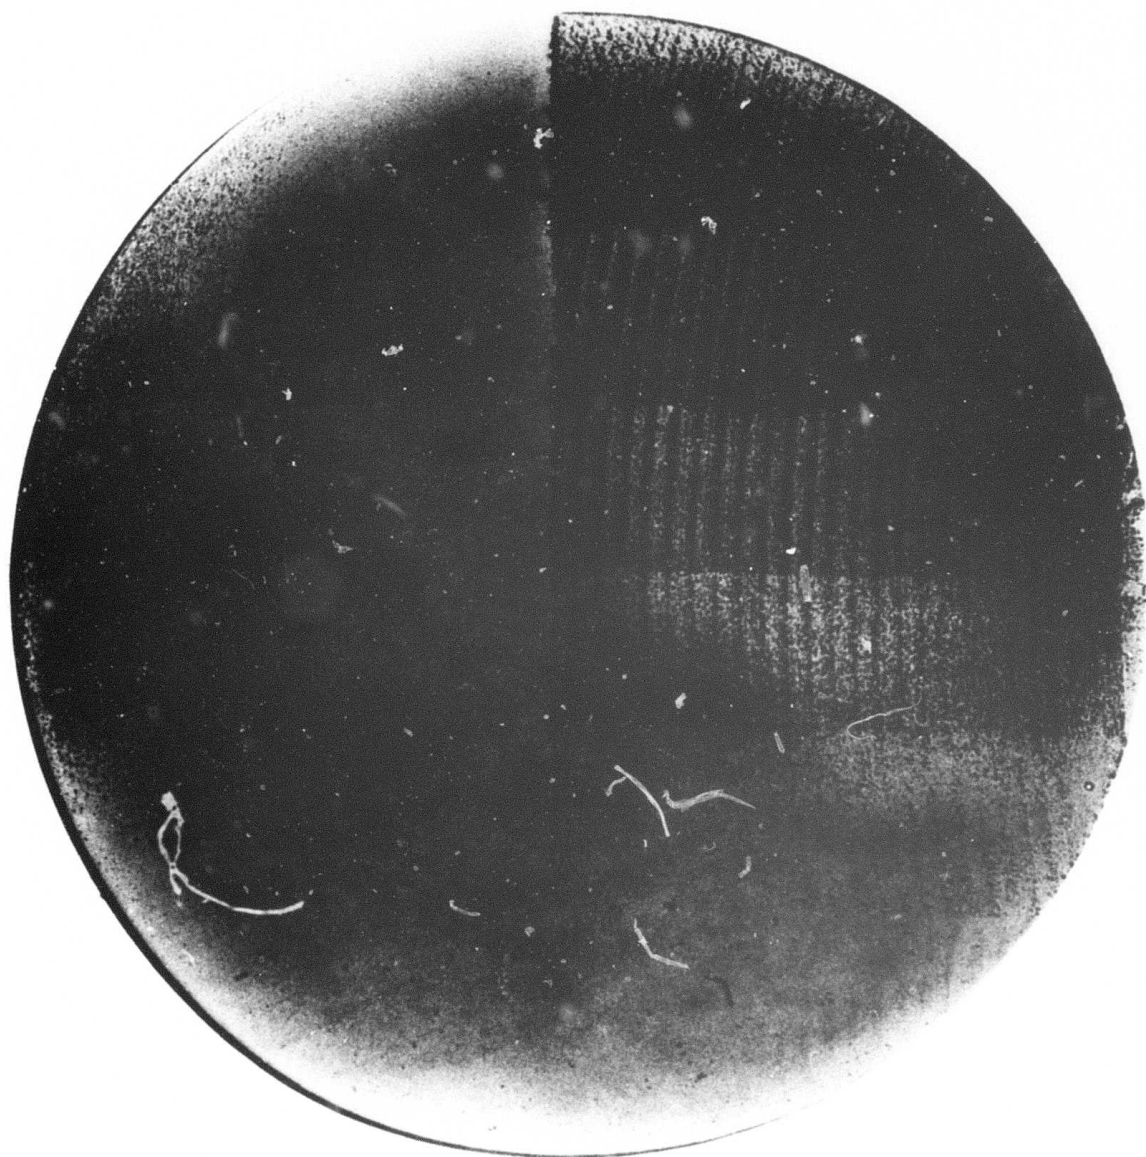
Fig. 10a. SOT topograph of B wafer, cut from end of crystal.
